Completion of Opening Unit 4 Reactor at Fukushima Daini Nuclear Power Station (September 10-21, 2012)

The opening of Unit 4 reactor at Fukushima Daini Nuclear Power Station was started on September 10 and has been completed on September 21 after removing the concrete hatch, PCV lid, RPV lid, steam dryer and steam-water separator.

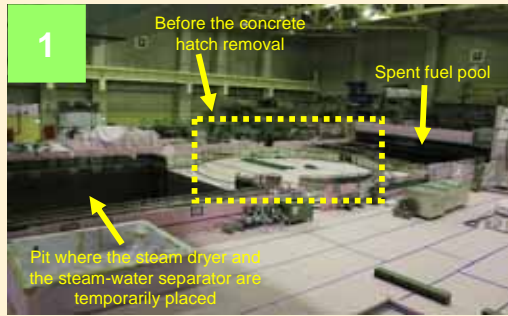
Before opening the reactor
(Photo taken on September 10, 2012)

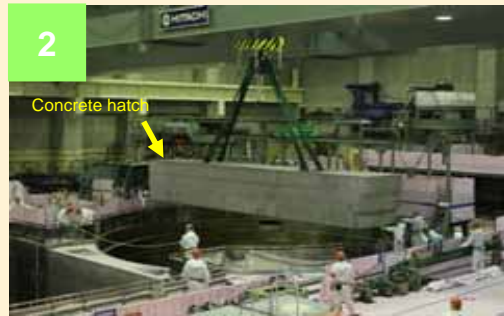
Concrete hatch removal
(Photo taken on September 10, 2012)

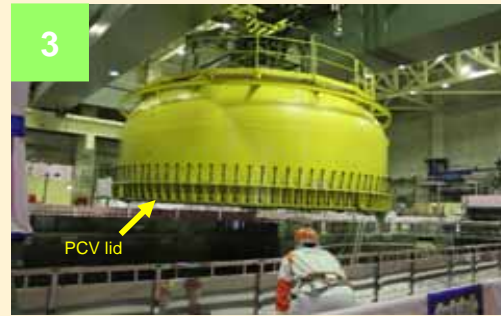
PCV lid removal
(Photo taken on September 11, 2012)

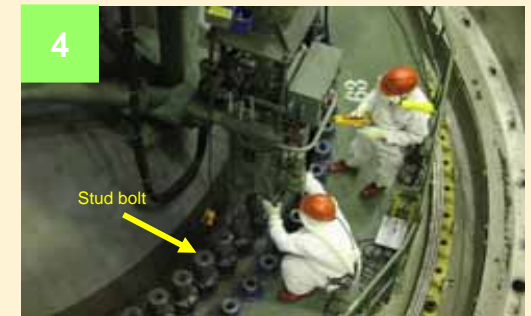
Loosening the RPV stud bolts
(Photo taken on September 13, 2012)

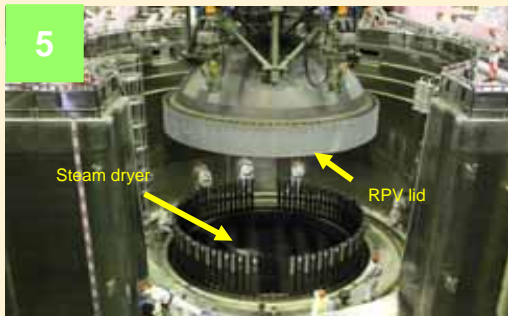
RPV lid removal
(Photo taken on September 14, 2012)

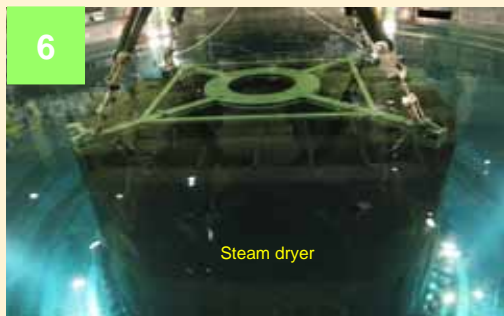
Steam dryer removal
(Photo taken on September 19, 2012)

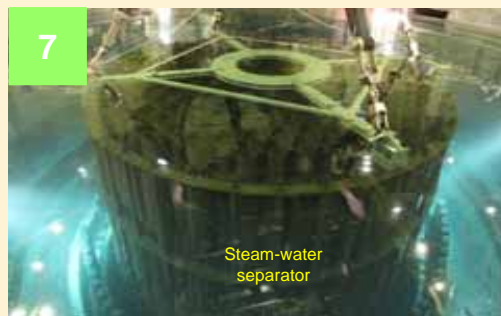
Steam-water separator removal
(Photo taken on September 21, 2012)

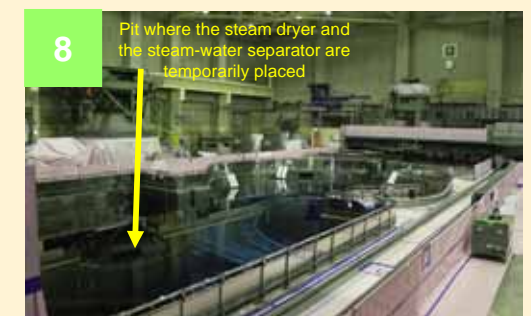
After the reactor was opened
(Photo taken on September 22, 2012)

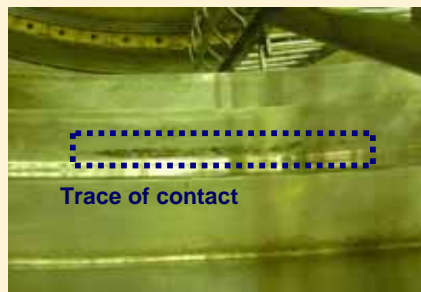
Traces of contact (scratches) were found on the surface of the second step (on almost all circumferences) where the concrete hatch was installed on. (Previously announced on our web page on September 13, 2012 [Discussed at the Non-conformances Management Committee on September 12]) As the scratches found were quite superficial, they have no negative impact on the soundness of the reactor. The scratches are assumed to be caused by the ground motion of the Tohoku-Chihou-Taiheiyou-Oki Earthquake.

Trace of contact 2
(Photo taken on September 11, 2012)
