[Diagram] Air leakage at Main Exhaust Stack of Unit 4, Fukushima Daini Nuclear Power Station

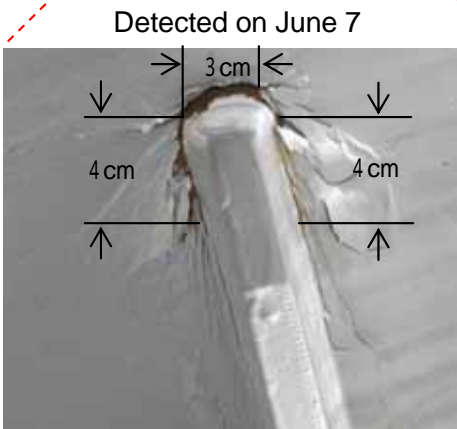
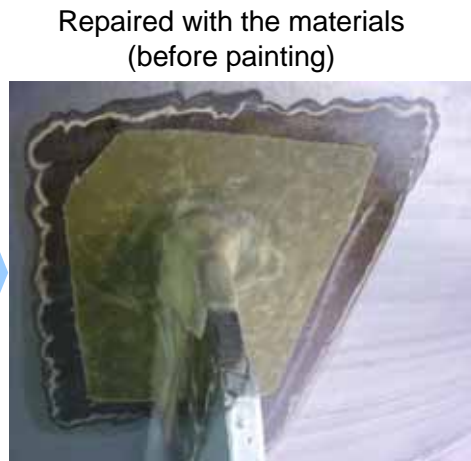
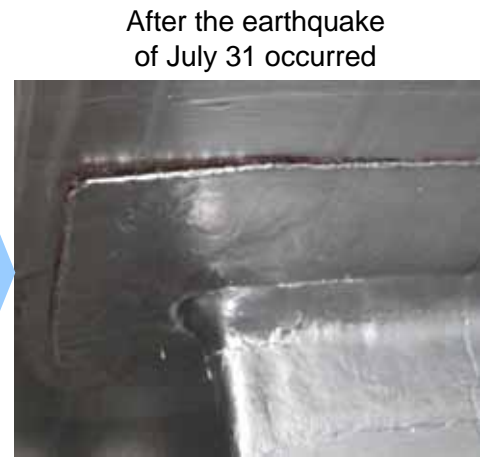
Leakage detected on June 7: Repaired  
Leakage detected again on July 31

Leakage detected on June 7: Repaired  
No abnormalities this time
